Concorde Battery Corporation

TECHNICAL BULLETIN

Subject: Thermal Runaway

November 12, 1997 Number: 2

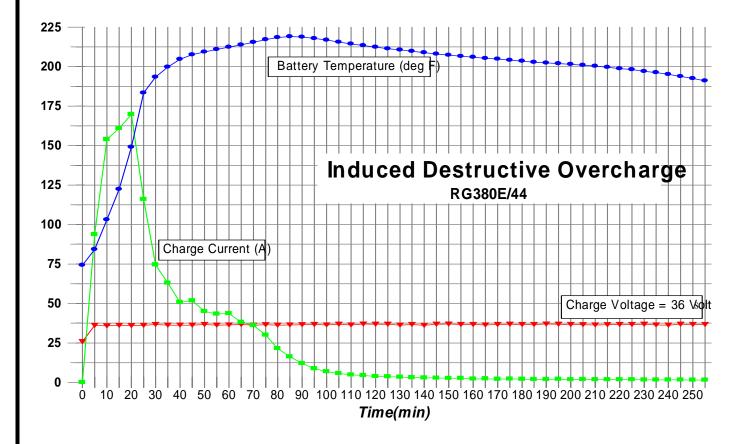
To demonstrate this, the Induced Destructive Overcharge Test in IEC standard 952-1:1988 is conducted. In this test, the battery is intentionally driven into thermal runaway by charging the battery at 3.0 volts/cell and continuing to charge until the battery fails. The battery must contain any flame within the battery both during and after the test, not release any electrolyte from the battery casing, and contain any debris resulting from an explosion either during or after the test. A graph of the typical result is shown on page 2:
